Guided Wave Inspection of Lamp Posts

Case Study 19

Lamp Post Inspection

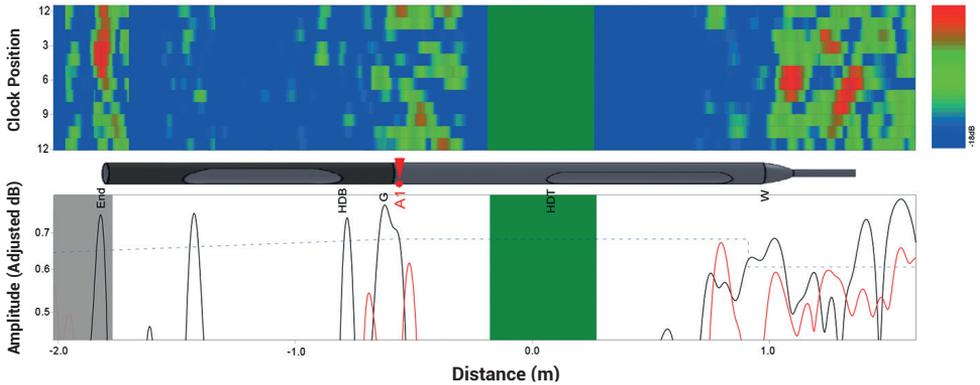
WavePro™ - GWT Results

The Wavemaker® result from one of the inspected lamp posts is shown above. A severe indication was detected 0.57m from the ring, a location just above the ground interface, extending over approximately 0.3m in the axial direction towards the ground. The circumferential position of the defect was also positively identified using the C-Scan result.

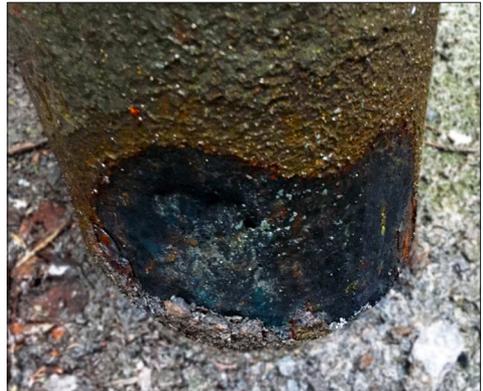
Following the removal of the galvanised coating, a detailed visual inspection found a corrosion patch near the ground interface with the most severe location corresponding to a through wall defect. As a result of the GWT findings, the inspector was able to inform the authority for immediate action.

Indication A1. A through-wall defect located on the section just above the ground interface of the lamp post.

Feature	Type	Location [m]	Length [m]	Notes
End	End of Post	-1.81	~	---
HDB	Hatch Door - Bottom Side	-0.82	0.5	Cabling access.
G	Ground Entrance	-0.59	~	Granular base tarmac.
A1	Severe Defect	-0.57	0.3	Severe. Extends 0.3m below ground.
HDT	Hatch Door - Top Side	+0.08	0.67	Fuse & Switch access.
W	Weld	+0.51	0.02	---
