Case Study 16: Erosion on Elbows

Job Details

- 10" crude oil line
- Non-painted surface
- Insulated pipeline
- Inspection of sleeved buried section

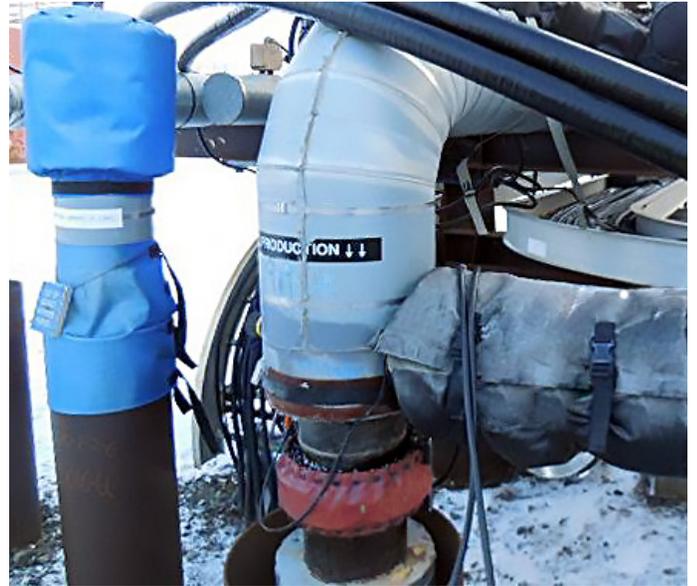
Overview of the ring installation site, where a short section of the pipeline insulation was removed.

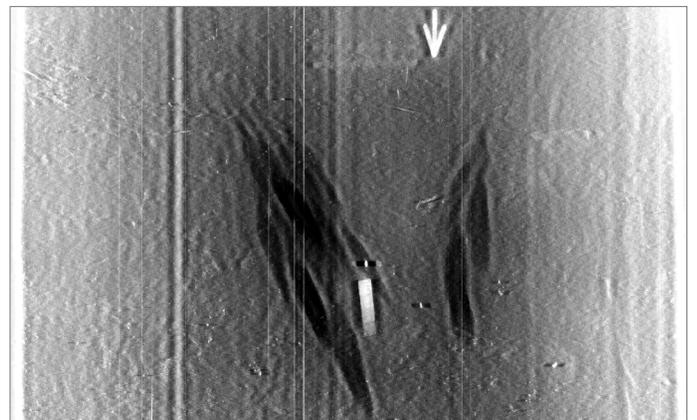
- A severe defect is detected on the sleeved buried elbow within the test range.
- Circumferential alignment of the defect with outer radius of the elbow suggests an erosion type defect.
- Excavation and removal of the sleeve allowed verifications to be performed.
- Results of RT inspection confirmed a severe erosion defect at the location reported by GWT.

Radiographic image of erosion defect located at the position reported by GWT.
