# EARLY DETECTION OF CORROSION IN JETTY LINES

PROACTIVE INTEGRITY MANAGEMENT THROUGH REMOTE MONITORING

# JETTY LINE MONITORING WITH gPIMS®

In 2022, a client installed gPIMS® sensors on multiple pipelines beneath and alongside a jetty structure to support integrity management. This case study focuses on one of these pipelines.

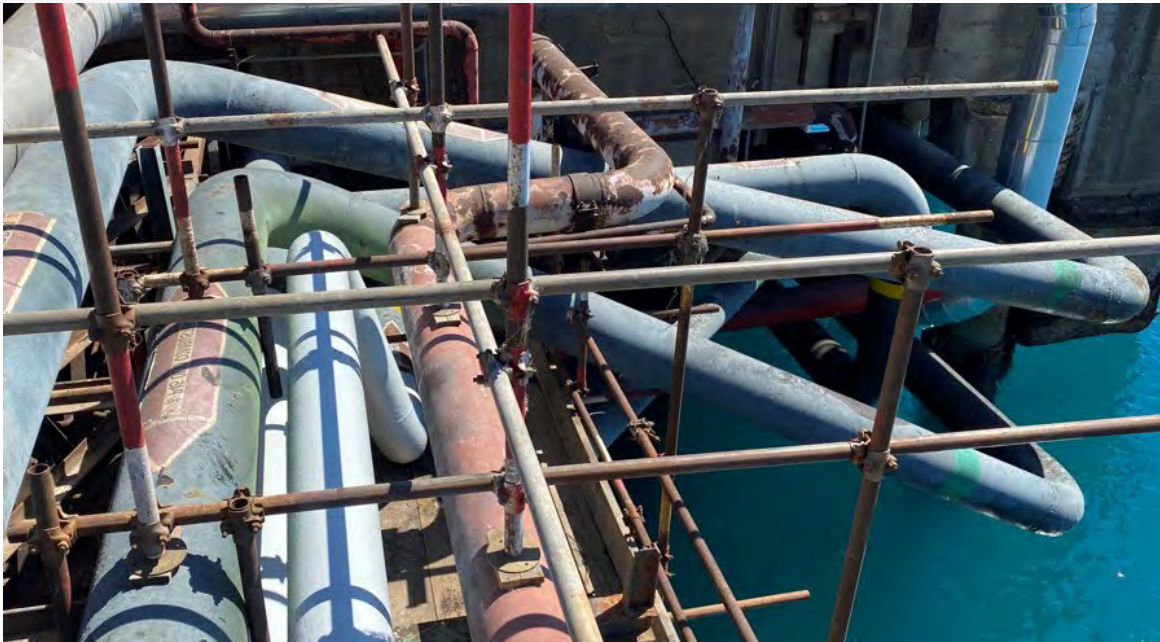
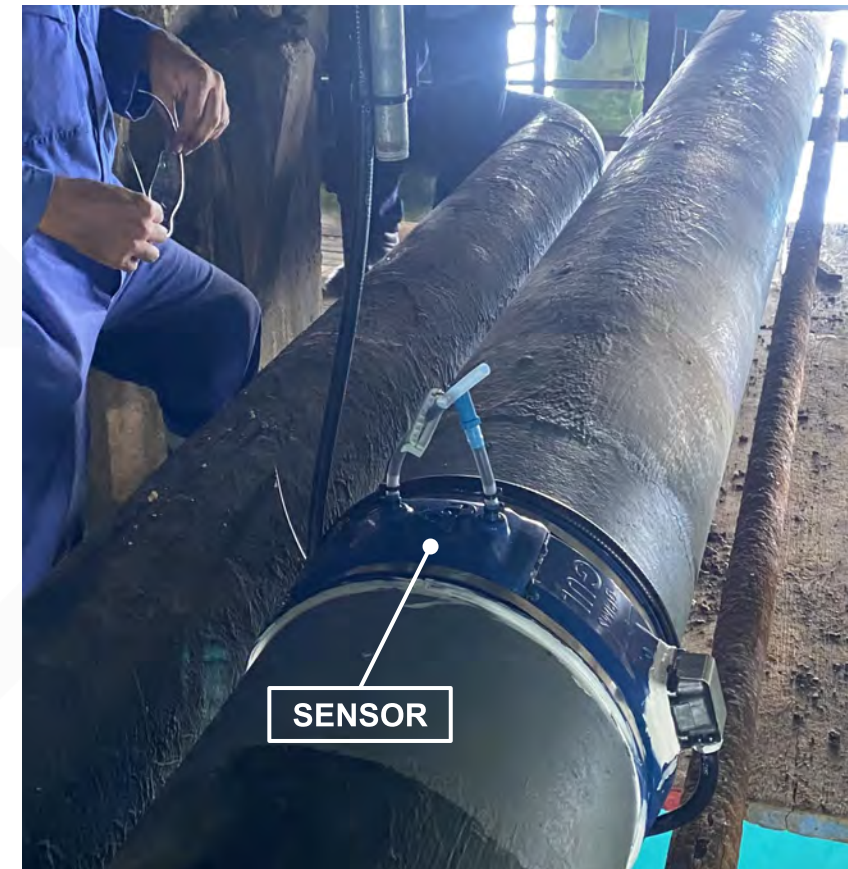
**16"**

Crude Oil  
Line

**12.7 mm**

WT  
(Wall Thickness)

**3.17 mm**

Corrosion  
Allowance

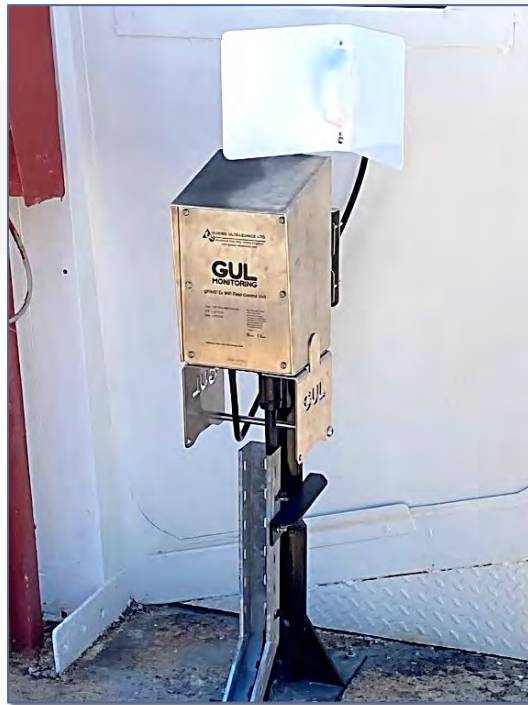
PIMS® FCU

The system delivers frequent data via a Wi-Fi connection provided by a Field Control Unit (FCU) directly to the desk of the client's corrosion engineers. The information from the sensors is accessed via the browser-based **GUL Monitoring Studio**.

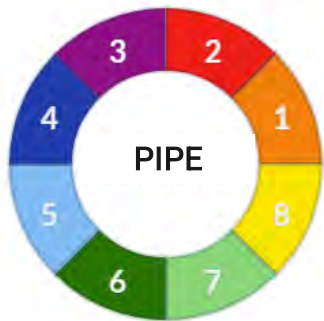
SENSOR SEGMENTS

Wall thickness measurements underneath the sensor remained stable throughout the monitoring period, showing there was no threat from generalized internal corrosion.

Minimum segment: 7

Minimum: 11.87 mm

Mean: 12.73 mm

Max: 13.87 mm

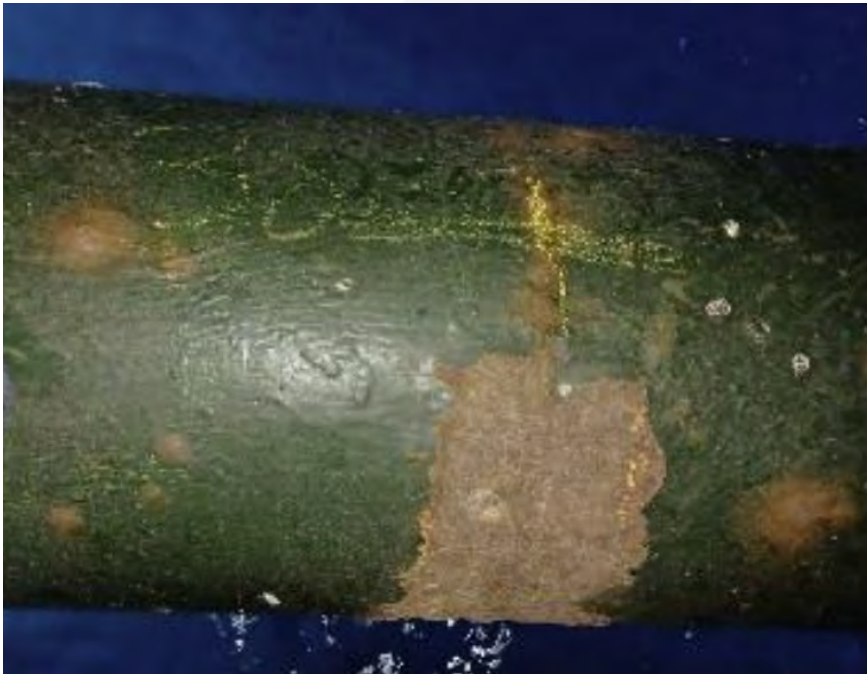
Visual follow-up inspection revealed corrosion scale in the area of the weld. The scale was removed and the area around the weld inspected:

- ♦ Visual testing: ~ 1–3 mm wall loss in the affected area
- ♦ Ultrasonic testing in area ①: minimum WT **10.8 mm**; in area ②: minimum WT 11.2 mm

Follow-up inspection recommended cleaning the affected area and reapplying a coating suitable for marine environments.
