Case Study 16: Erosion on Elbows

Job Details

- 10" crude oil line
- Non-painted surface
- Insulated pipeline
- Inspection of sleeved buried section

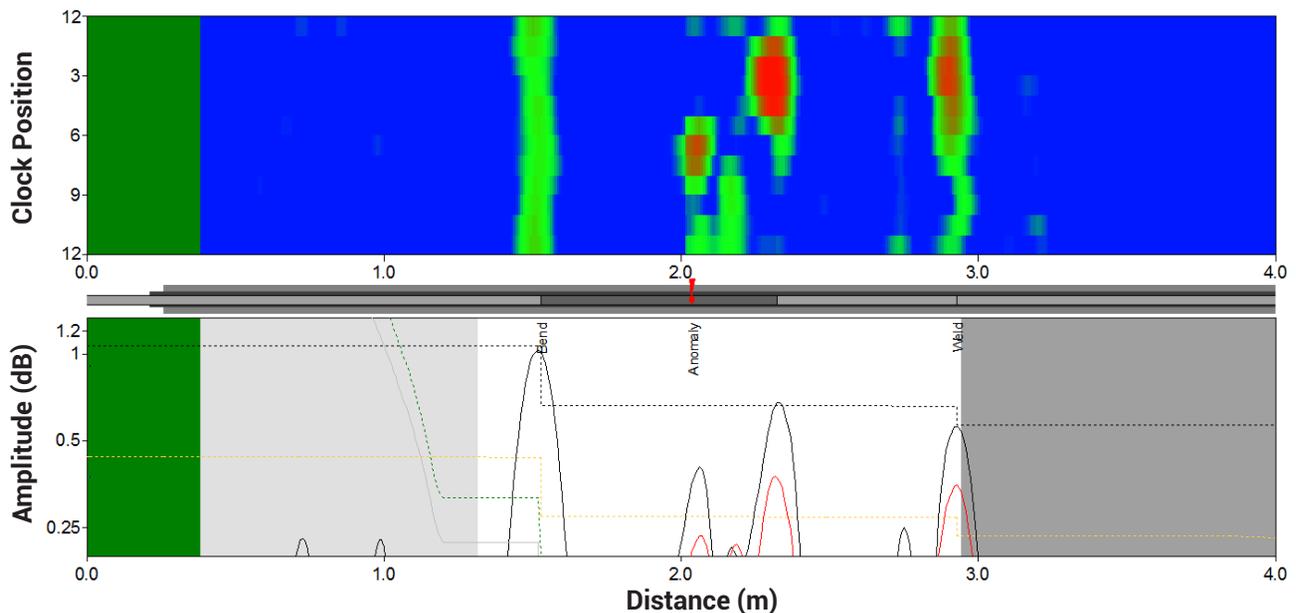
- A severe defect is detected on the sleeved buried elbow within the test range.
- Circumferential alignment of the defect with outer radius of the elbow suggests an erosion type defect.
- Excavation and removal of the sleeve allowed verifications to be performed.
- Results of RT inspection confirmed a severe erosion defect at the location reported by GWT.
